<b>Solomon Elementary School District, #5</b>		2250 S. Stevens Ave Solomon, AZ 85551
	Amendment #2		
	IFB: 20-02-22 PROJECT: Roofing and Weatherization Improvements of Gym at Solomon Elementary School	Page 1 of 59

**LIMITED ASBESTOS  
AND LEAD PAINT  
SURVEY REPORT**

**SOLOMON SCHOOL  
GYMNASIUM BUILDING  
HVAC DECK ROOFING AND EXTERIOR  
2250 SOUTH STEVENS AVENUE  
SOLOMON, ARIZONA 85551**

Inspection Date: March 2, 2018

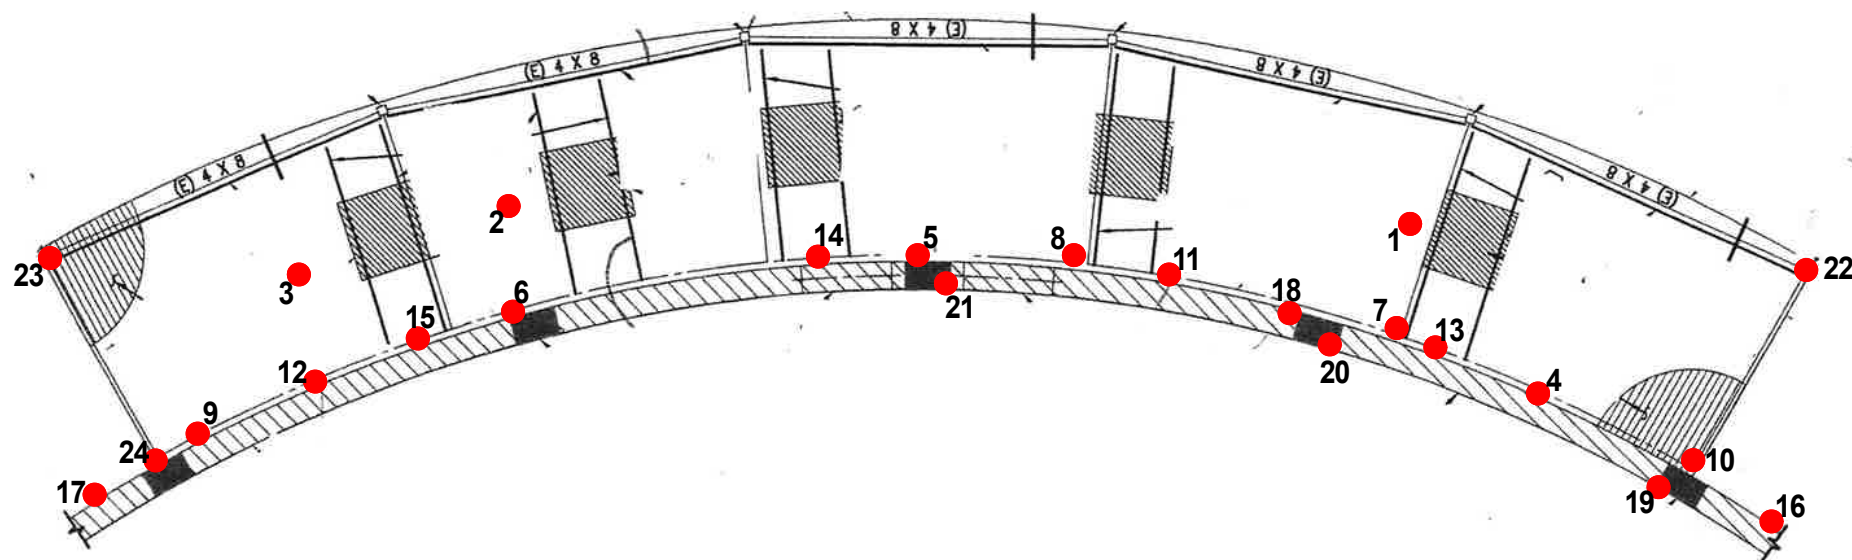
PLM Bulk Sample Location Map  
 Solomon Elementary School  
 2250 South Stevens Avenue, Solomon, Arizona 85551

All nine (9) of the homogeneous materials sampled were reported by the laboratory using the PLM analysis method to be “none detected” for asbestos-content.

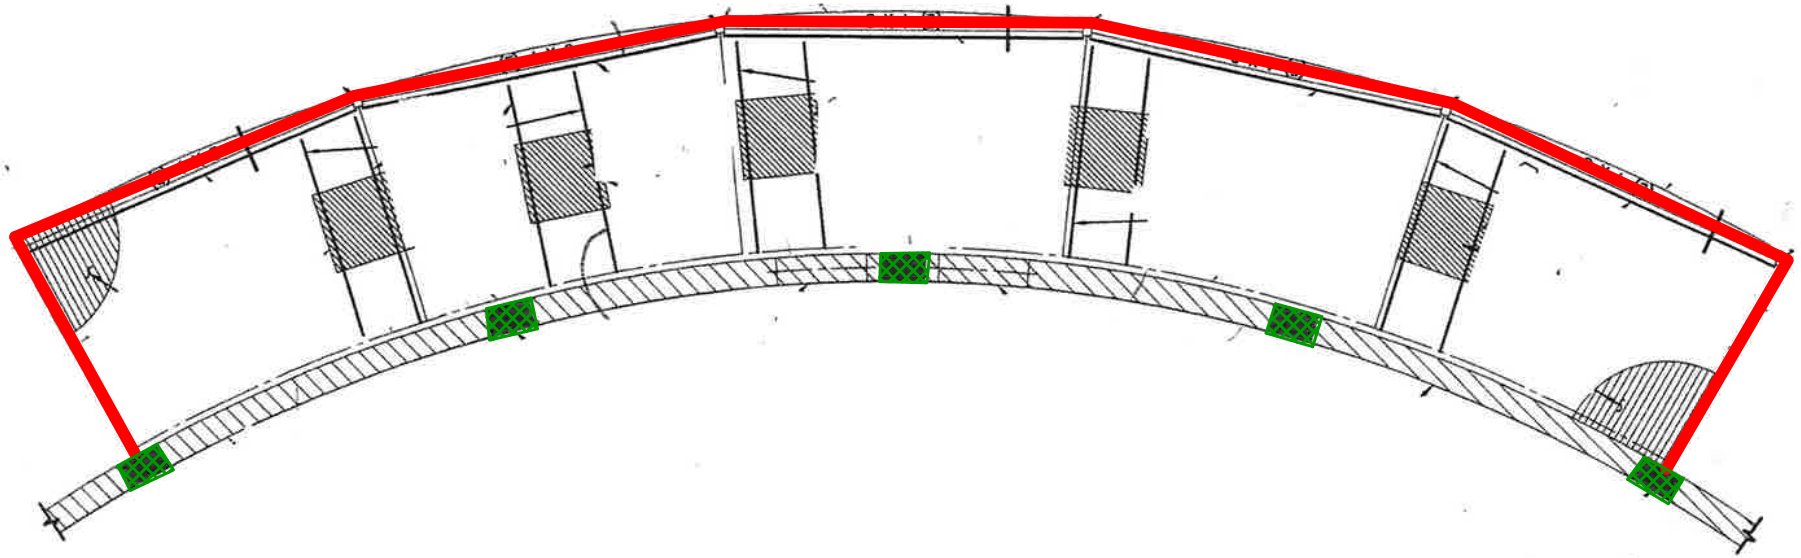
**Lead-Containing  
White Concrete Column Paint**

Dominion recommends that the regulatory guidelines listed above are followed during any disturbance of the paint identified to contain lead. Any building materials identified with lead-containing/\*based paint that will be impacted during the renovation should be removed by a qualified lead-containing paint abatement. Dominion also recommends that the non-lead-containing paint building materials that are attached to a building material with lead-containing/based paint, be removed by a qualified lead-containing paint abatement contractor. The contractor should comply with all governing regulatory agencies having jurisdiction over lead-containing paint removal projects.

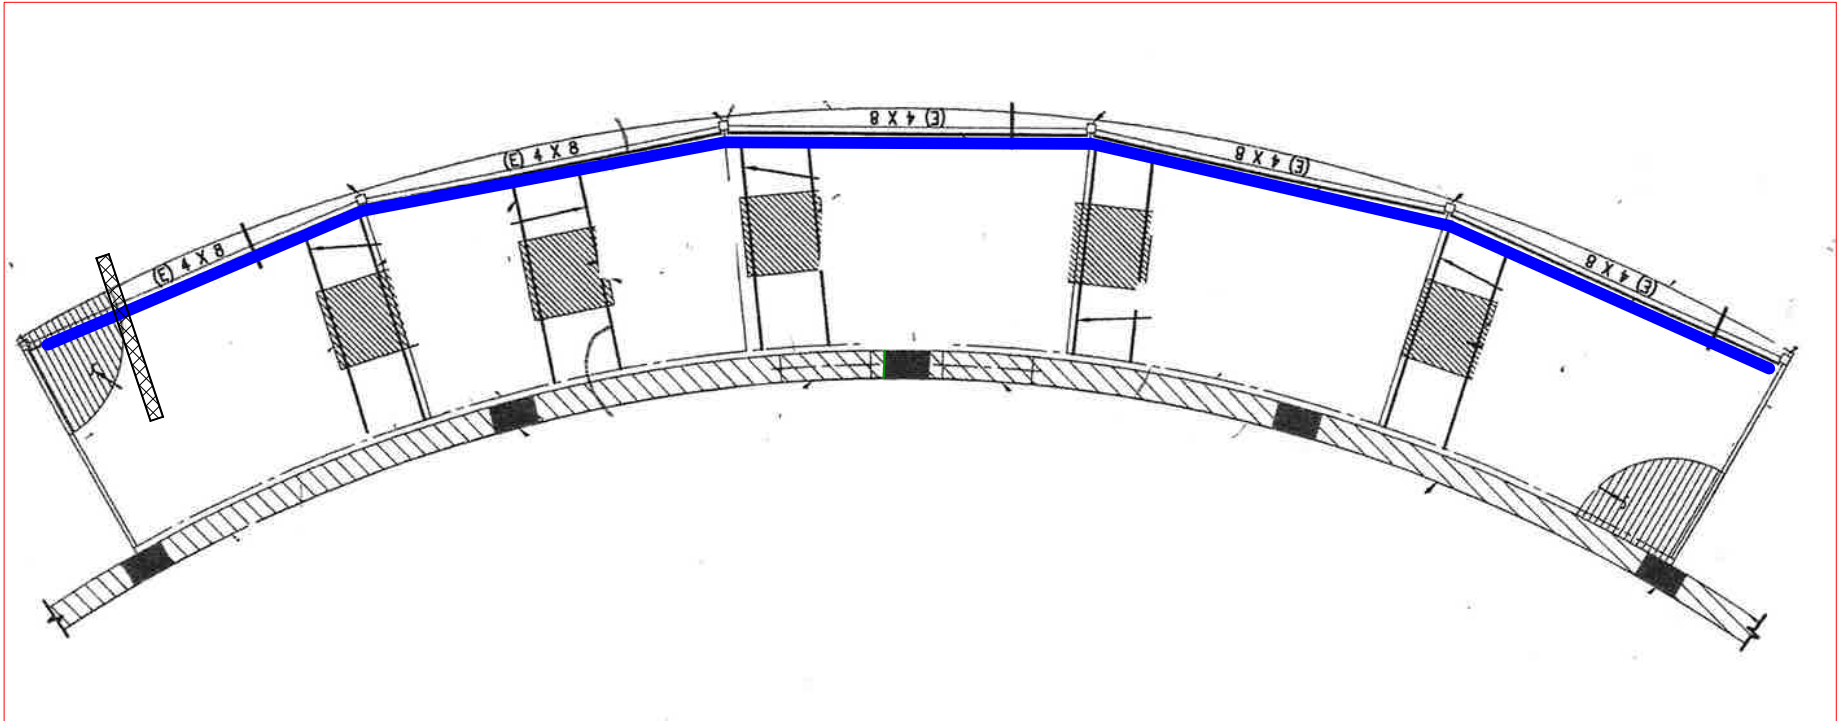
**Lead-Based  
White Handrail Paint**
